Manhole Inspection Summary

Manhole # S13UU1011MH

Insp Date: **4/11/07 2:51 PM**

Location Address: **NORTHERN PKWY**

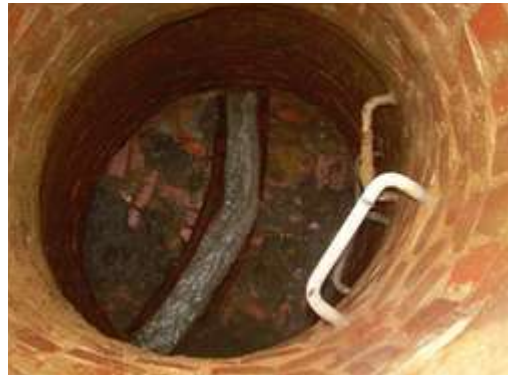
Top View

Corroded steps. Evidence of surcharge - Bench debris.

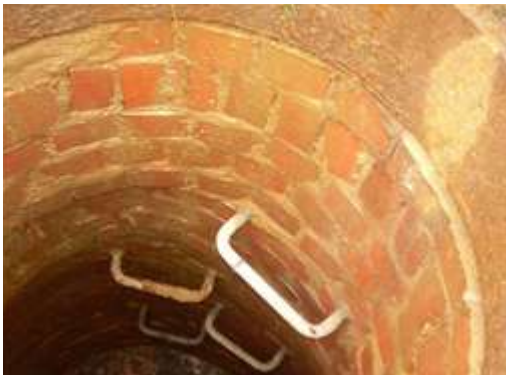
Defect

Frame leaks. Adjustment, Corbel and Barrel infiltration.

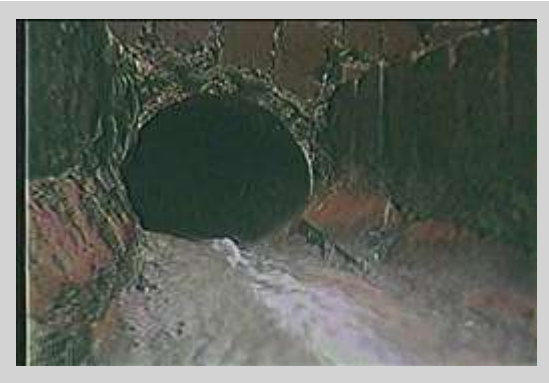
8 in. Circular Gravity Sewer Pipe Out @ 12 O'Clock

Barrel deterioration and infiltration. Channel deterioration.

Infiltration: **None** Pipe Seal Cond: **Cracked**

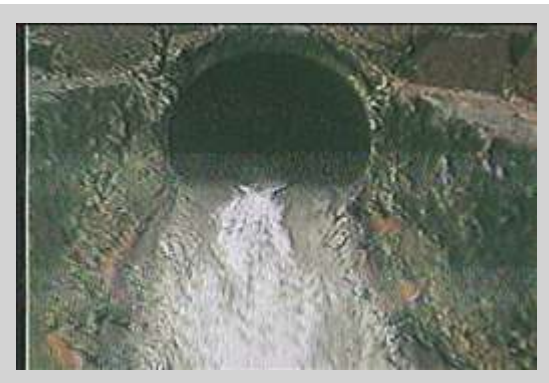
8 in. Circular Gravity Sewer Pipe In @ 8 O'Clock

Deposits: ☐ None ☐ Mud ☐ Sludge ☐ Debris ☒ Grease

Silt Depth: **0** (in.) Deposits Extent: **Light**

Infiltration: **Evidence** Pipe Seal Cond: **Cracked**
